**Engineering Field Trip Report**

**Friant Dam Enlargement**

### **Study Team Field Trip Report (June 12, 2002)**

# Upper San Joaquin River Storage Investigation Field Trip Logs

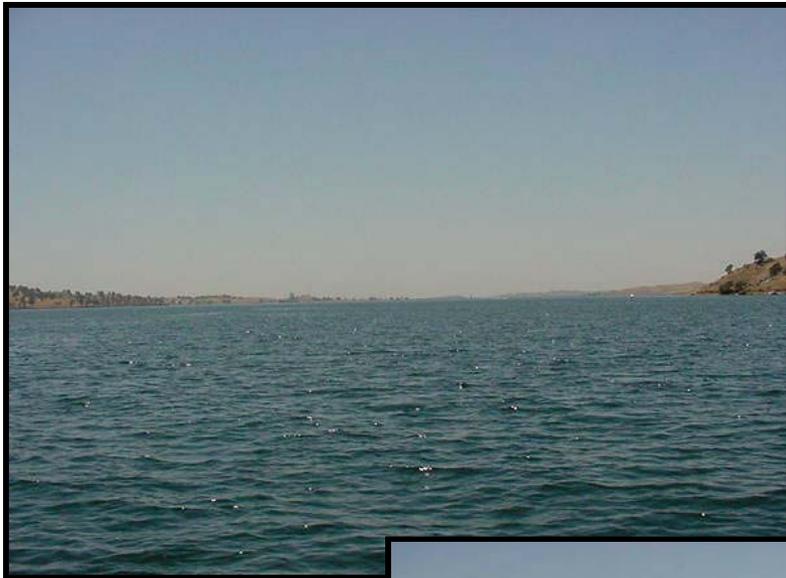
Friant Dam/ Lake Millerton  
– Southwesterly view,  
toward the dam.

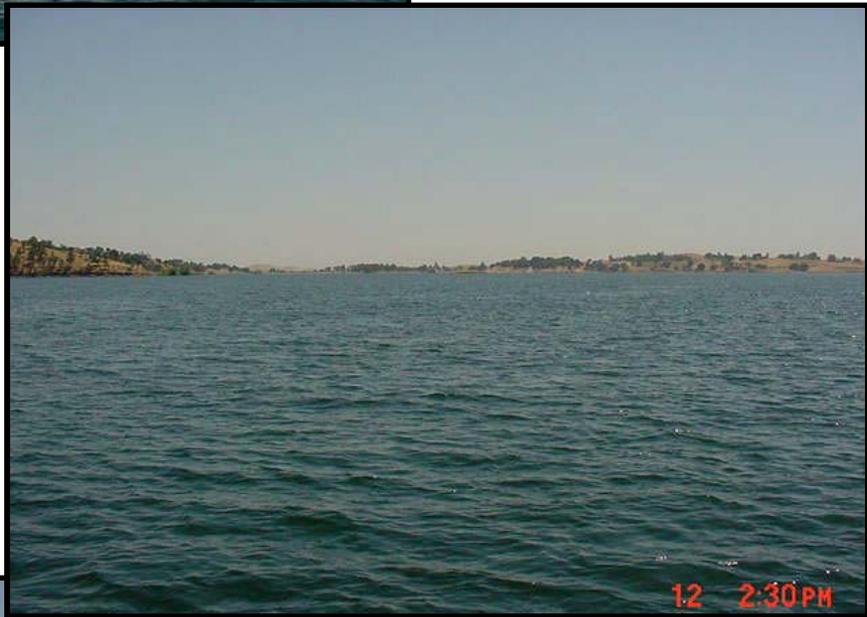
Southerly view of the low-  
lying area east of the dam.

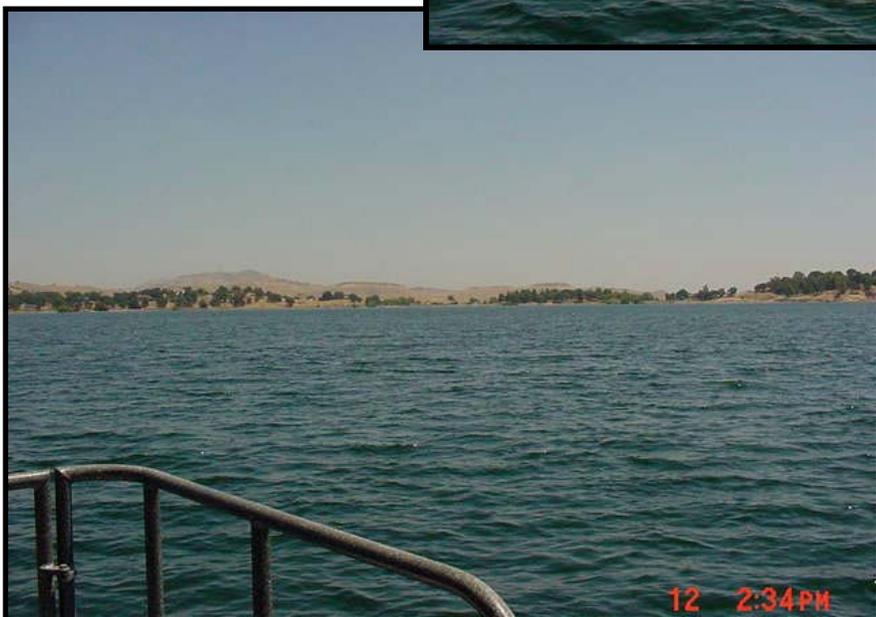
Southerly view of the low-lying  
area east of the dam.

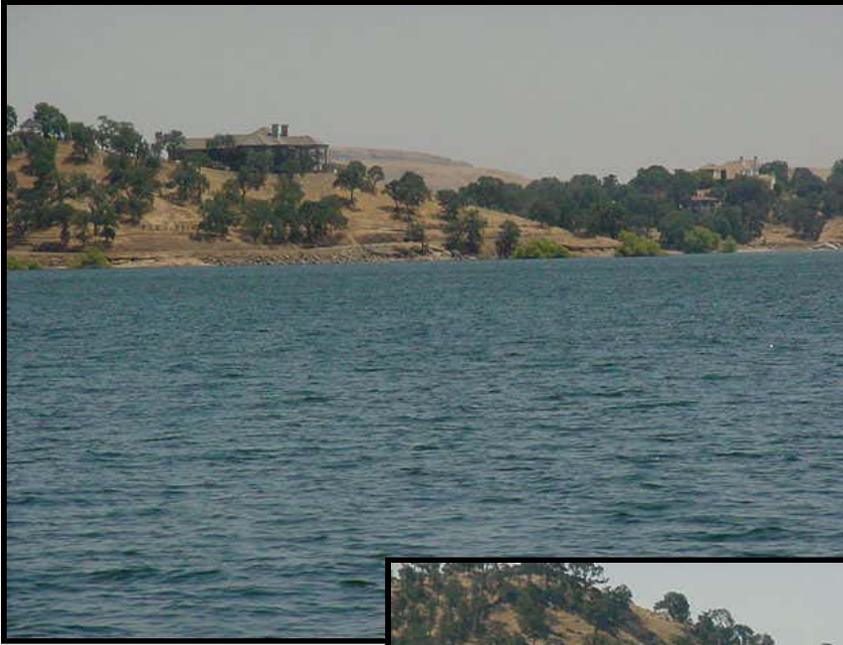
Southerly view of homes near shore just upstream of Winchell Bay.

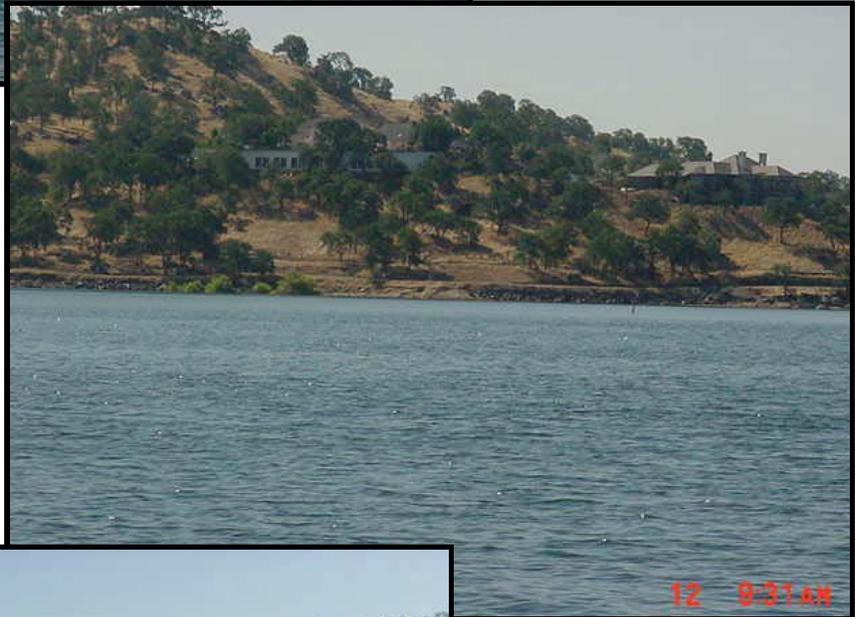
Southerly view of homes near shore upstream of Winchell Bay.

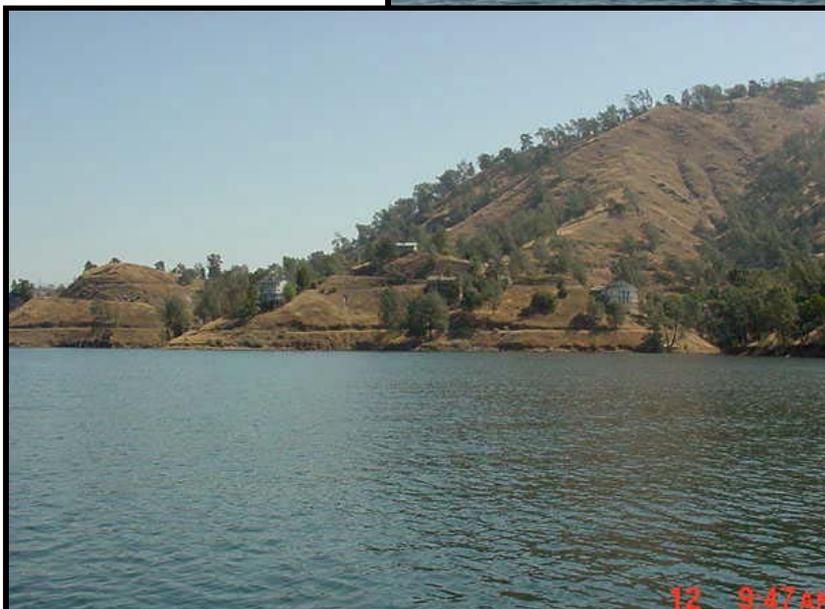
Southerly view of homes near shore upstream of Winchell Bay.

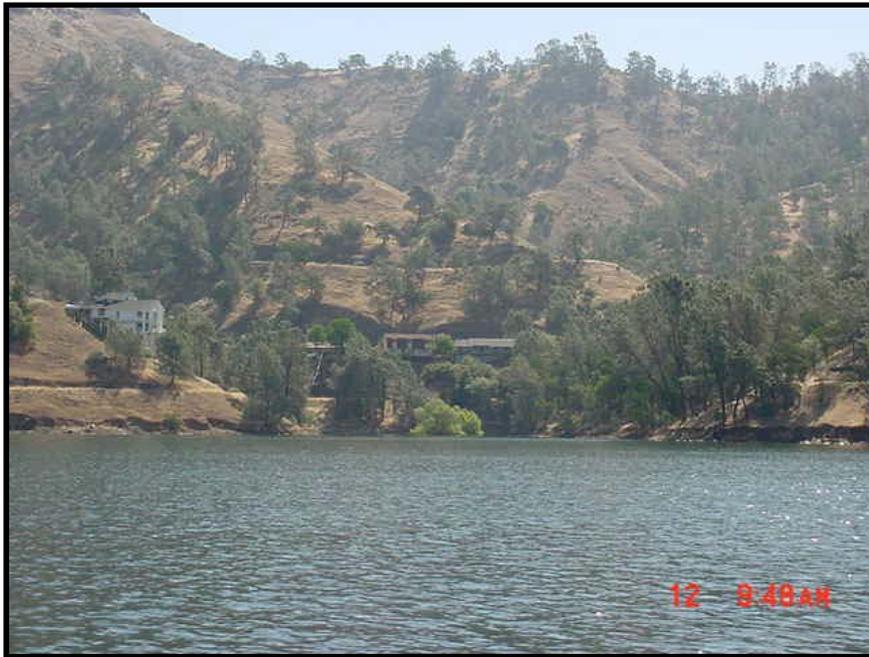
Northerly view of homes near shore downstream of Fine Gold.

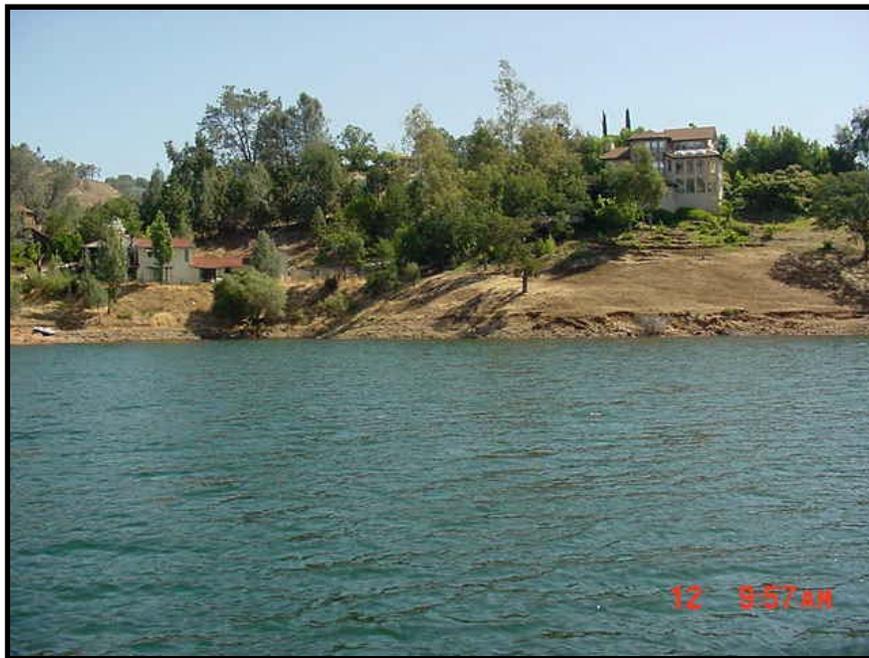
Northerly view of homes near shore downstream of Fine Gold. Lowest home on lake is at left.

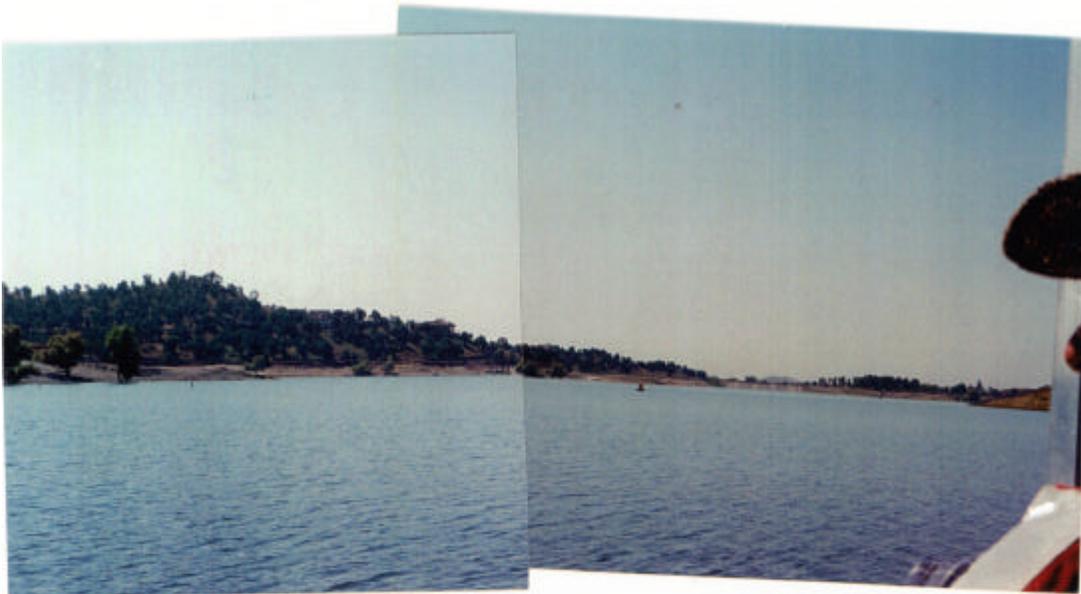
Photo 1

View to the south of the low terrain extending south-southeast from the high ground immediately left (southeast) of the left abutment of Friant Dam to approximately 1.5 miles southeast of the dam. One of the California State Parks boat ramps is visible at right center. Raising Friant Dam would require that a dike be constructed in this low area along the reservoir rim.

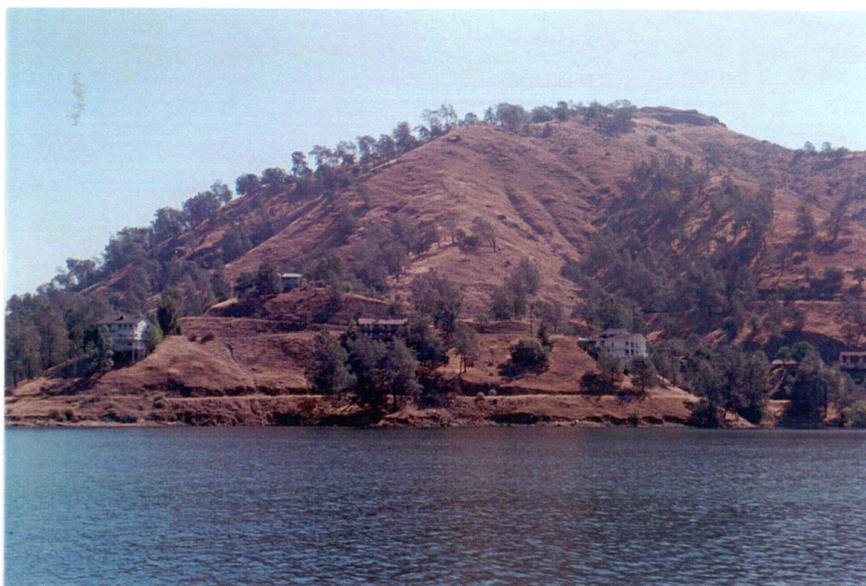
Photo 2

View to the east of the community of Sky Harbor, located 4 miles upstream (northeast) of Friant Dam, with Pincushion Mt. in the background. Sky Harbor includes approximately 30 homes and is one of two residential communities located on the shoreline of Millerton Lake.

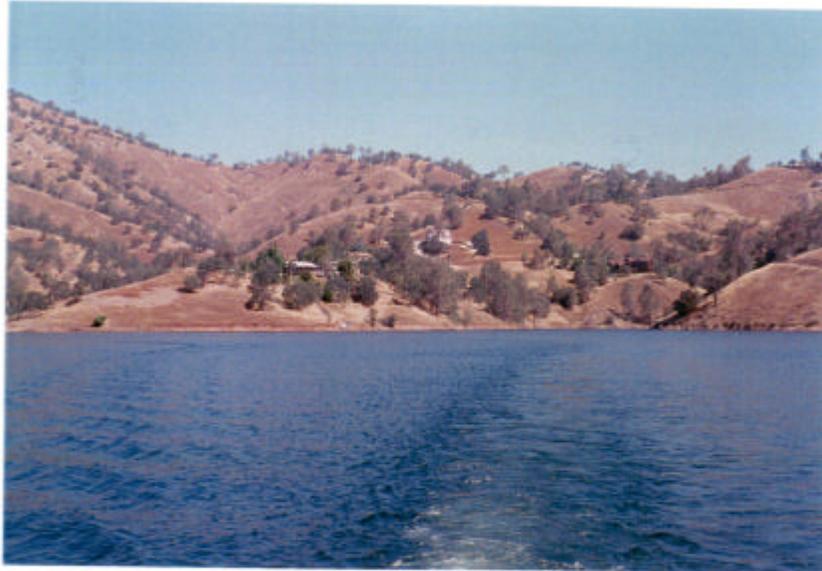
Photo 3

View to the north of the community of Hidden Lake Estates located 5 miles upstream (north) of Friant Dam. Hidden Lake Estates includes approximately 45 homes and is located immediately west of Fine Gold Damsite.

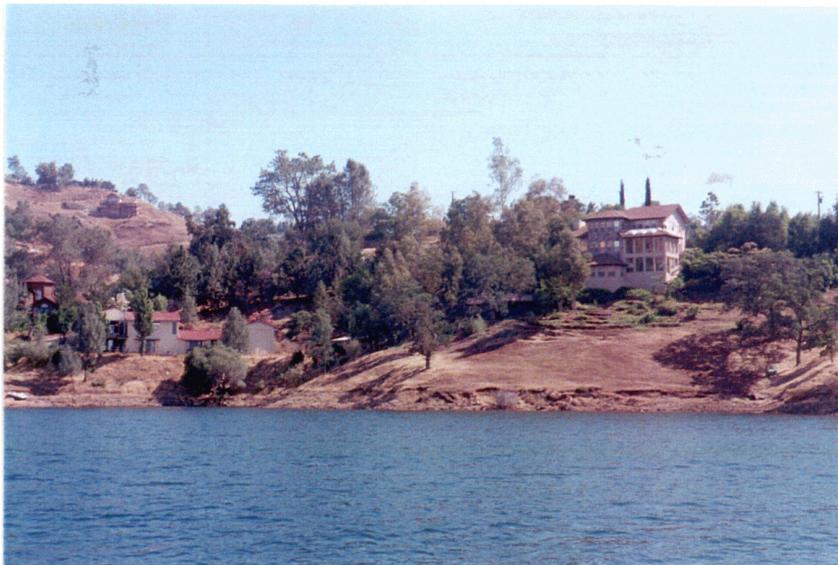
Photo 4

Closeup view to the north of homes in the community of Hidden Lake Estates. The home shown at lower left is at the lowest elevation of any home located along the Millerton Lake shoreline.

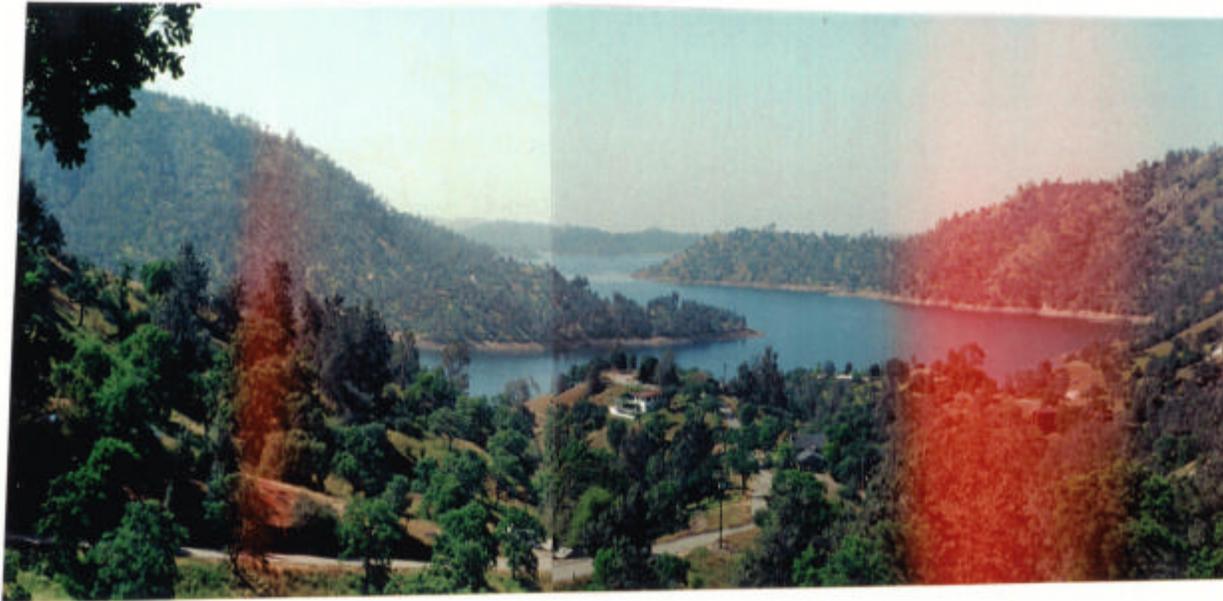
Photo 5

View to the south of the community of Hidden Lake Estates with Sky Harbor, Pincushion Mt. and Millerton Lake in the background.

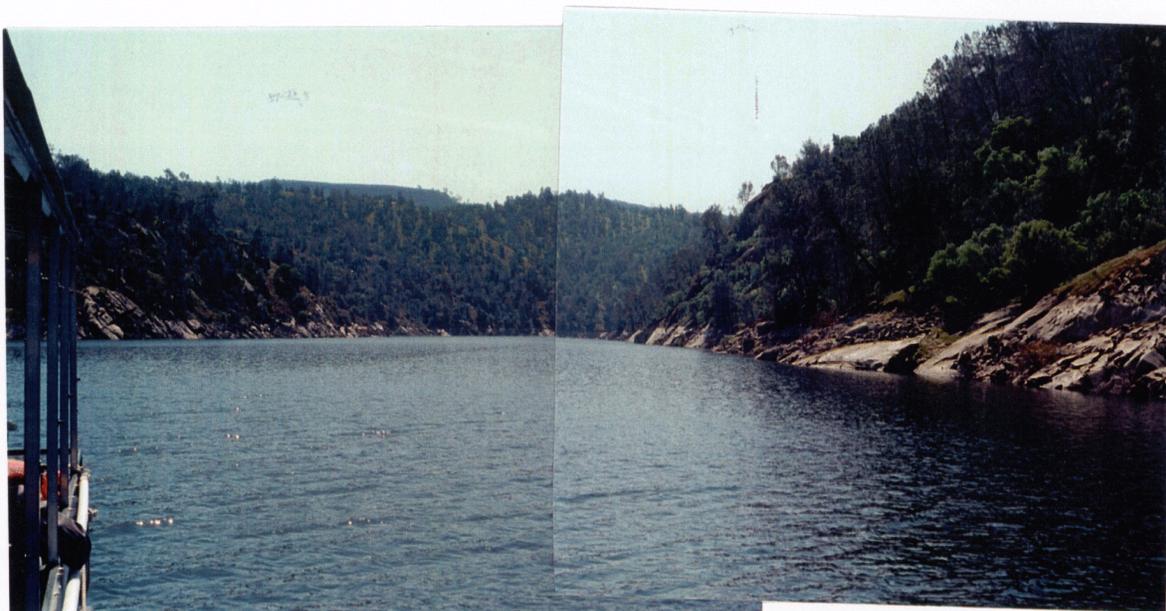
Photo 6

View upstream (southeast) of the damsite. Steep lower slopes expose hard, water-scoured moderately to slightly fractured granitic rock.

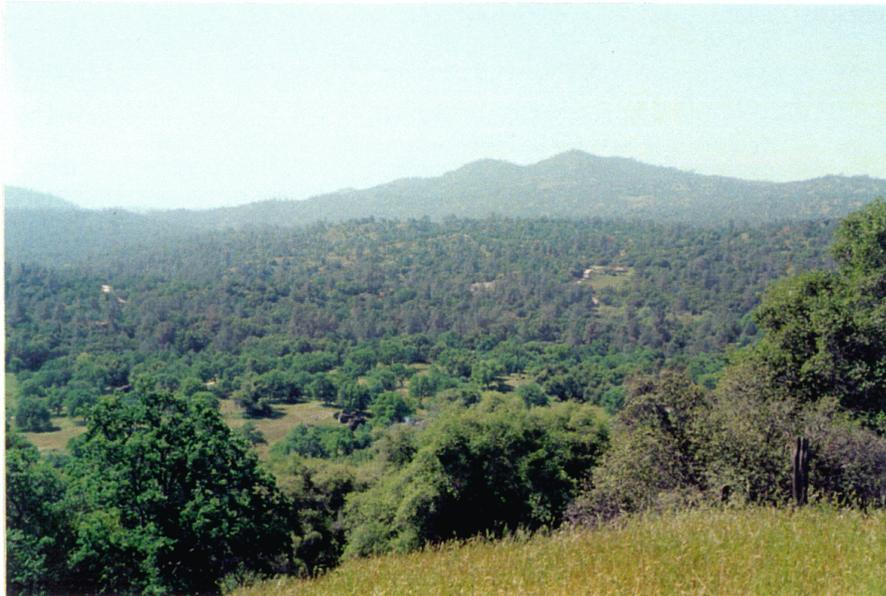
Photo 27

Panoramic view to the southwest of the reservoir area. The highest peak in the background is Hulbert Mtn. (El. ).

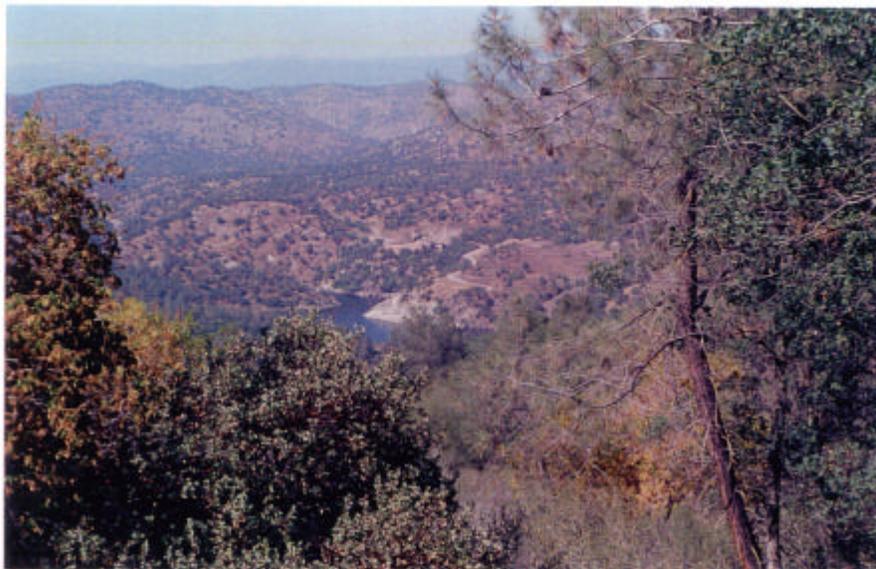
Photo 28

Panoramic view to the northeast of the San Joaquin River canyon from the road just south of Temperance Flat. Kerckhoff Powerhouse No. 1 and a waste berm are visible at photo center. The waste berm is composed of "tunnel muck" (mostly granitic rock fragments) that was produced by the excavations for the underground powerhouse and access tunnels.
